Manhole Inspection Summary

Manhole # S19W__015MH

Location Address: **2300 washington bd**

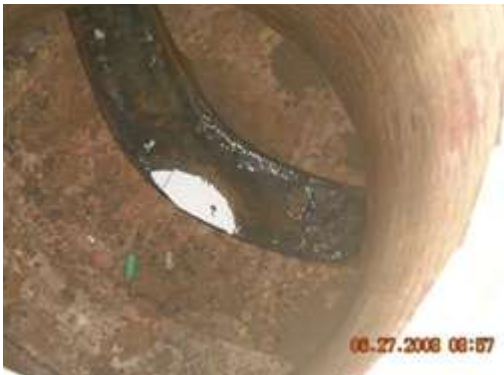
Defect 2

Condition: ☐ Sound ☐ Cracked ☐ Root Intrusion ☐ Deteriorated ☐ Leaks ☒ **Debris**

debris in channel

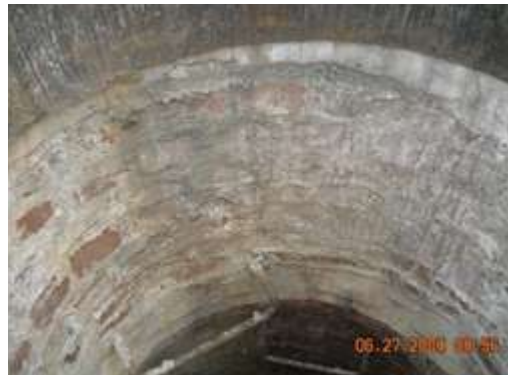
Defect 1

☒ **Leaks**

Infiltration: ☐ None ☒ **Joint** ☐ Cracks ☐ Mortar ☐ Roots ☒ **Wall**

chimney flow wall /frame leaks, chimney joint, chimney parged

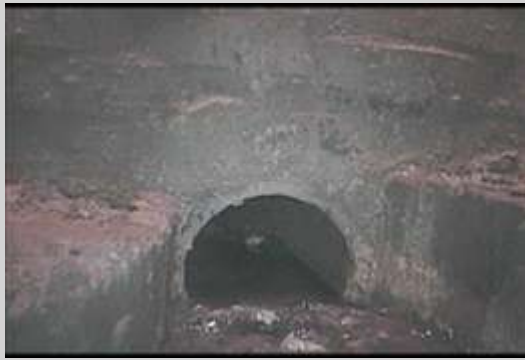
12 O'Clock Outflow

8 in. Circular Gravity Sewer
Pipe Out @ 12 O'Clock

Pipe Height: **8.4** (in.) Rod and Bar (Angled)
Pipe Material: **Clay** ☐ Pipe Lined
Invert Depth: **11.98** (ft.) Flow Characteristics: **Slow**
Deposits: ☐ None ☒ **Mud** ☒ **Sludge** ☐ Debris ☐ Grease
Silt Depth: **2** (in.) Deposits Extent: **Light**
Infiltration: **None** Pipe Seal Cond: **Sound**

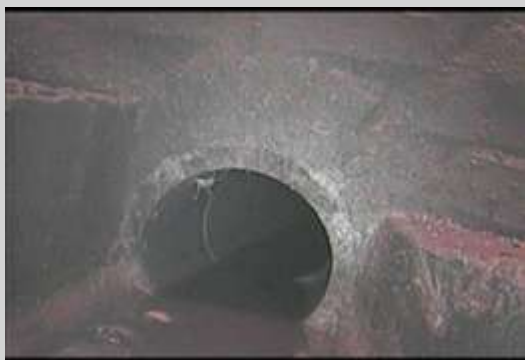
7 O'Clock Inflow

8 in. Circular Gravity Sewer
Pipe In @ 7 O'Clock

Pipe Height: **8.4** (in.) Rod and Bar (Angled)
Pipe Material: **Clay** ☐ Pipe Lined
Invert Depth: **11.89** (ft.) Flow Characteristics: **Slow**
Deposits: ☒ **None** ☐ Mud ☐ Sludge ☐ Debris ☐ Grease
Silt Depth: **0** (in.) Deposits Extent:
Infiltration: **None** Pipe Seal Cond: **Sound**
